A coastal landslide at West Down Beacon, Budleigh Salterton, Devon

P.G. KALAUGHER
P. GRAINGER

*P.G. Kalaugher, Department of Engineering Science, University of Exeter, Devon.
P. Grainger, Department of Geology, University of Exeter, Devon.*

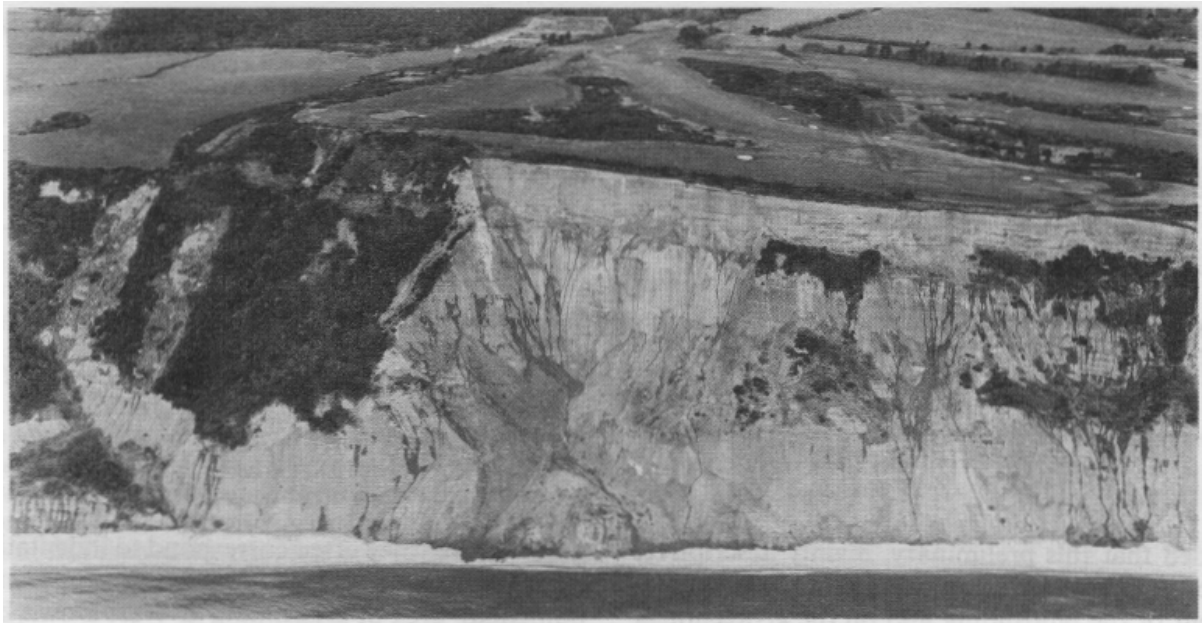
Examination of aerial photographs shows that there have been major changes in the morphology of the cliffs in the last few decades. The detailed morphology during 1980 (Fig. 1) is largely the result of movement of the main landslide following a major fall of conglomerate from the upper cliff in September 1979. The positions of geological features referred to in the text are shown in the accompanying drawing (Fig. 2). The line of the cross-section (Fig. 3) drawn through the main landslide is also indicated in Fig. 2. Topographic surveying is by terrestrial photogrammetry with a Wild P32 camera mounted on a TI theodolite but only approximate analytical methods have so far been used.

Figure 1. Oblique aerial view of West Down Beacon with the main landslide area in the middle of the picture. Photograph by J. Saunders on 22nd March 1980.

It is probable that some points of discharge of groundwater from the mudstone, similar to those visible in Fig. 1, become blocked by the debris. Wherever the debris is relatively impermeable and a higher point for the discharge has to be found, the groundwater pressure is increased. This means that, before a fall from the conglomerate, the effective stresses in the potential slip zone between the mudslide and the in situ mudstone may already be somewhat lower than expected.

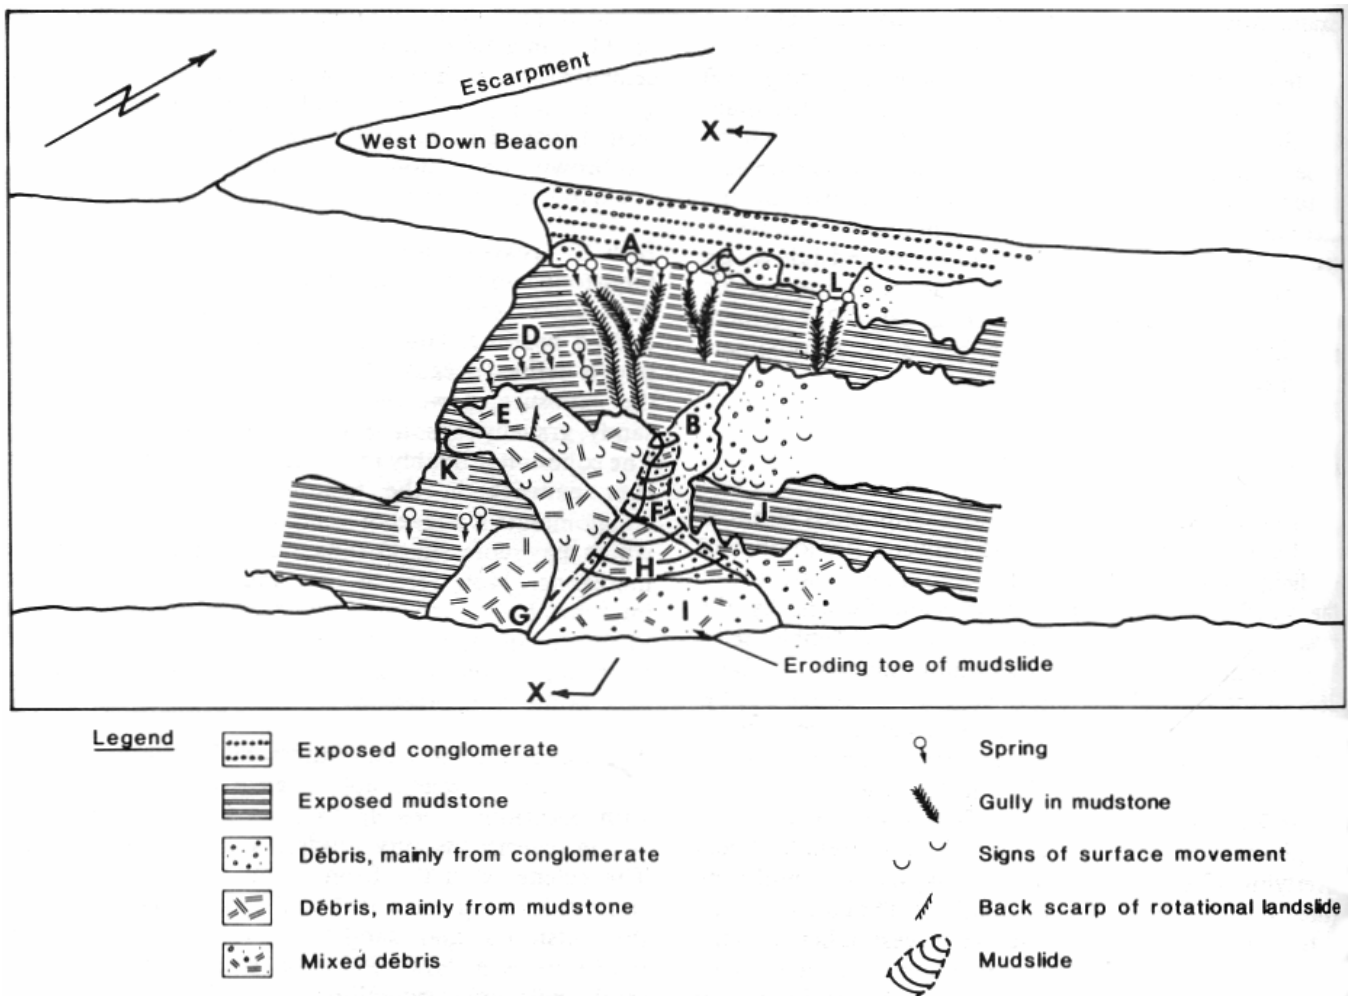
Figure 2. Interpretation of the landslide area of Figure 1. X-X indicates the line of the cross-section, Figure 3. The other letters mark areas referred to in the text.

The groundwater emerging (e.g. at A in Fig. 2) causes seepage erosion at the base of the very weakly cemented conglomerate and assists in its oversteepening. This leads to sudden falls of the cliff above. The larger falls, occurring every few years, cause cliff-top recession of the order of 2 to 3 metres and involve near-vertical slices of conglomerate. The shape of the upper cliff suggests that poorly developed joints partly control the geometry of the slices. There is a range in scale from these infrequent large falls down to the falling of individual pebbles, which becomes a continuous process during the winter months. Typically the debris from the large falls rapidly reaches B (Figs. 2 and 3) but that from the small scale falls can form screens on the ledge on top of the mudstone and be banked up against the lower part of the conglomerate as at C.

The emergent groundwater runs over the mudstone in the cliff face, softening the surface and forming gullies. The thin resistant beds of grey siltstone and silty sandstone to some extent impede this gully development. As can be seen at D (Fig. 2) water also emerges from the mudstone at particular levels, some of which correspond to the grey layers. The gully erosion and surface softening lead locally to instability of the fissured and jointed mudstone and there are frequent falls of blocks up to 0.5m in size. These blocks disintegrate and soften rapidly on exposure.

On the western side at E where there is only a little conglomerate debris, the softened mudstone has been affected by rotational slips and the resulting backtilting has interrupted the surface drainage. The slips direct some material into the main slide area between B and F while other material is contributed to the flow of debris towards G (Fig. 2).

On both sides of the main landslide area, at J and K (Fig. 2), a hard band in the mudstone forms a capping to the lowermost part of the cliffs. The drainage from the base of the conglomerate at L was diverted from the main landslide area towards J by the debris from the fall in September 1979. This drainage adds water to the conglomerate debris on the shallow slope immediately above the hard band. Sand, gravel and cobbles in a mudstone slurry flow over the hard band and onto the beach.

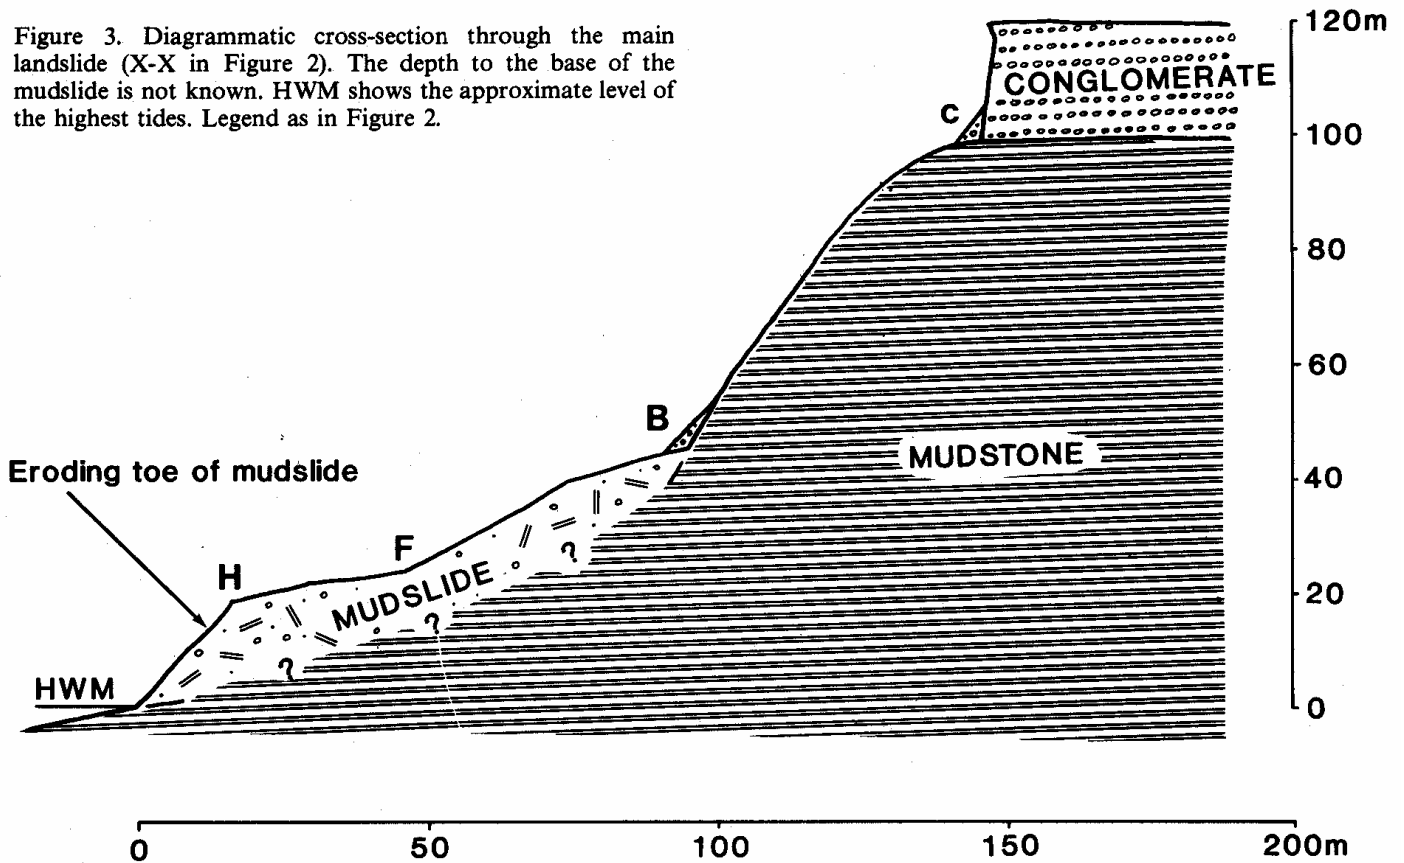
Figure 3. Diagrammatic cross-section through the main landslide (X-X in Figure 2). The depth to the base of the mudslide is not known. HWM shows the approximate level of the highest tides. Legend as in Figure 2.
