RENEWED LANDSLIDE ACTIVITY AT PINHAY, LYME REGIS

P. GRAINGER AND P. G. KALAUGHER

Grainger, P. and Kalaugher, P.G. 1995. Renewed landslide activity at Pinhay, Lyme Regis. *Proceedings of the Ussher Society*, **8**, 421-425.

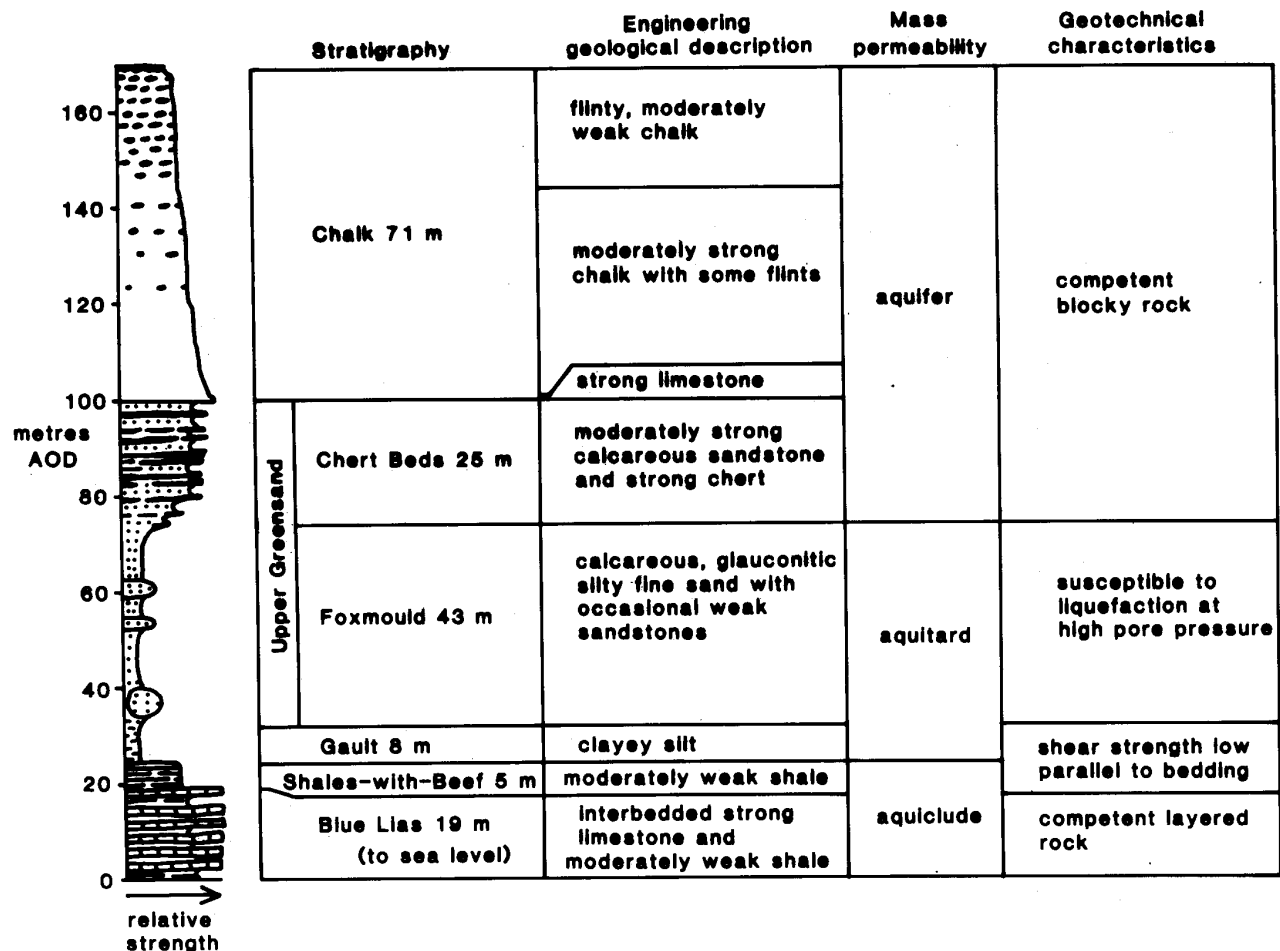
All of the strata in this area, where undisturbed by landsliding, are very gently dipping or virtually horizontal. The succession and significant geotechnical features of the formations, from sea level to the top of the cliff, are shown in Figure 2, which represents an interpretation of published geological information, taken from Grainger *et al.* (1985).

Figure 2. Stratigraphic column, with important properties (after Grainger et al., 1985).

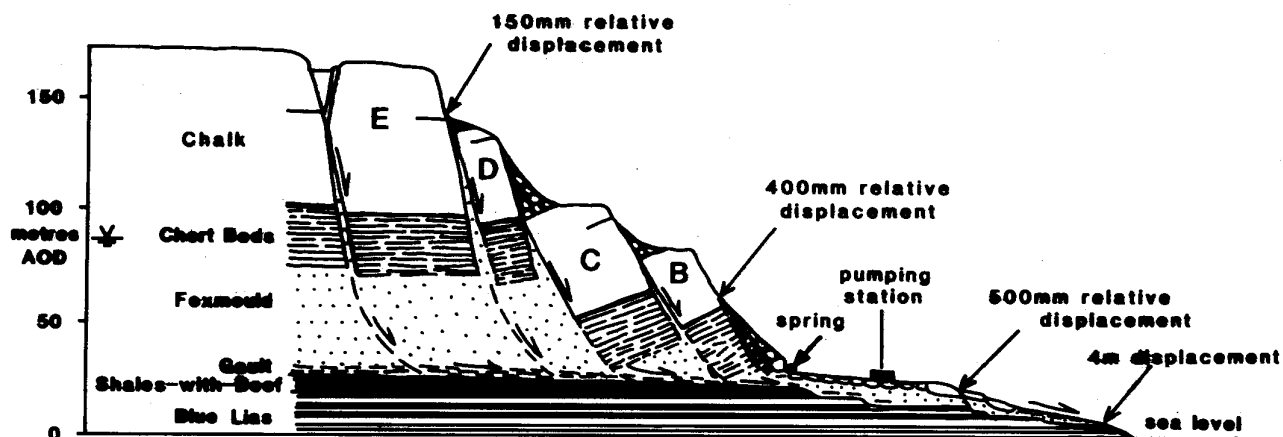
The geological cross section through the pumping station (Figure 3) demonstrates the interpreted mechanisms of landsliding at the site (Grainger *et al.*, 1985). Large blocks of Chalk and Chert Beds became detached along steeply inclined joints, subsided into the partially and temporarily liquefied Foxmould sand and rotated to form the stepped ground surface profile seen today. The orientation of the scarps between the blocks is consistently east-west, suggesting a structural control on the jointing which the scarps follow. It is inferred that basal sliding occurs at the level of the unconformity between the Gault and Shales-with-Beef. The unconformity also acts as a hydrological barrier to downward movement of groundwater (Pitts, 1983).

The Lias bedrock beneath the area from the pumping station down to the beach is overlain by landslide debris from the Chalk, Chert Beds, Foxmould and Gault (Figure 3). The debris gets thinner towards the sea where its rate of movement over the eroded Lias surface increases. The detailed study of this area in 1982-84 showed a strong correlation of the rate of movement with high rainfall (Grainger *et al.*, 1985). The backscarp of the active part of this debris slide is approximately 33 m seawards of the pumping station. At the toe of the slope, the debris descends to beach level where it is removed by wave erosion.

Figure 3. Cross section through the pumping station (after Grainger et al., 1985) showing positions of displacements recorded in February-March, 1994.

This series of site visits had thus revealed there had been relative movements between the large blocks upslope from the pumping station. Two of these downward displacements, in front of block E (150 mm) and block B (400 mm) were traced laterally to the track and road, distances of 1000 m and 400 m respectively. These movements, consistent over considerable distances, demonstrate the deep-seated nature and vast scale of the major landslide blocks. The movements also explain the coincidental damage to the power lines, water main, spring source and access road first seen on 23 February 1994. The possibility of minor undetected movements seaward of blocks D and C and landward of block E also exists. All of the above movements appeared to achieve at least temporary stability by the beginning of March.

The rear part of the shallow landslide seaward of the pumping station underwent a movement of about 500 mm on its backscarp. Between the backscarp and the toe there appears to have been stretching and the toe had moved seawards relative to the foreshore by approximately 4 m. The major part of these movements took place between 21 February and 24 February.
